### Silicon identification

This errata sheet applies to the revision A, Z, Y and X of STMicroelectronics STM32L053x6/8 microcontrollers.

The STM32L053x6/8 devices feature an ARM® 32-bit Cortex®-M0+ core.

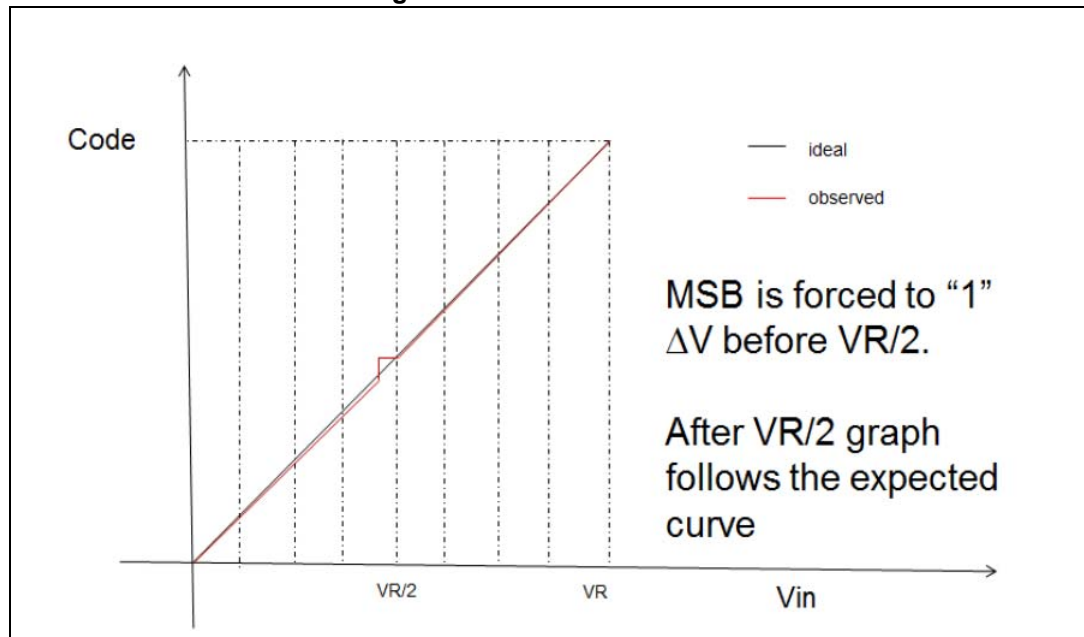
Figure 1. Data transfer curve

When  $V_{REF+}$  is lower than  $V_{DDA}$ , and only in this case, the data MSB is forced to '1' just before  $V_{IN}$  reaches  $V_{REF+}/2$ . As a result, the data transfer curve shows a discrepancy around  $V_{REF+}/2$  (see [Figure 1](#)).

Note: The transfer curve behaves as expected when  $V_{IN}$  is strictly lower or higher than  $V_{REF+}/2$ .
